Crystal Lake Flooding Analysis

Potential Drainage Improvements

Flood Complaint Area 4

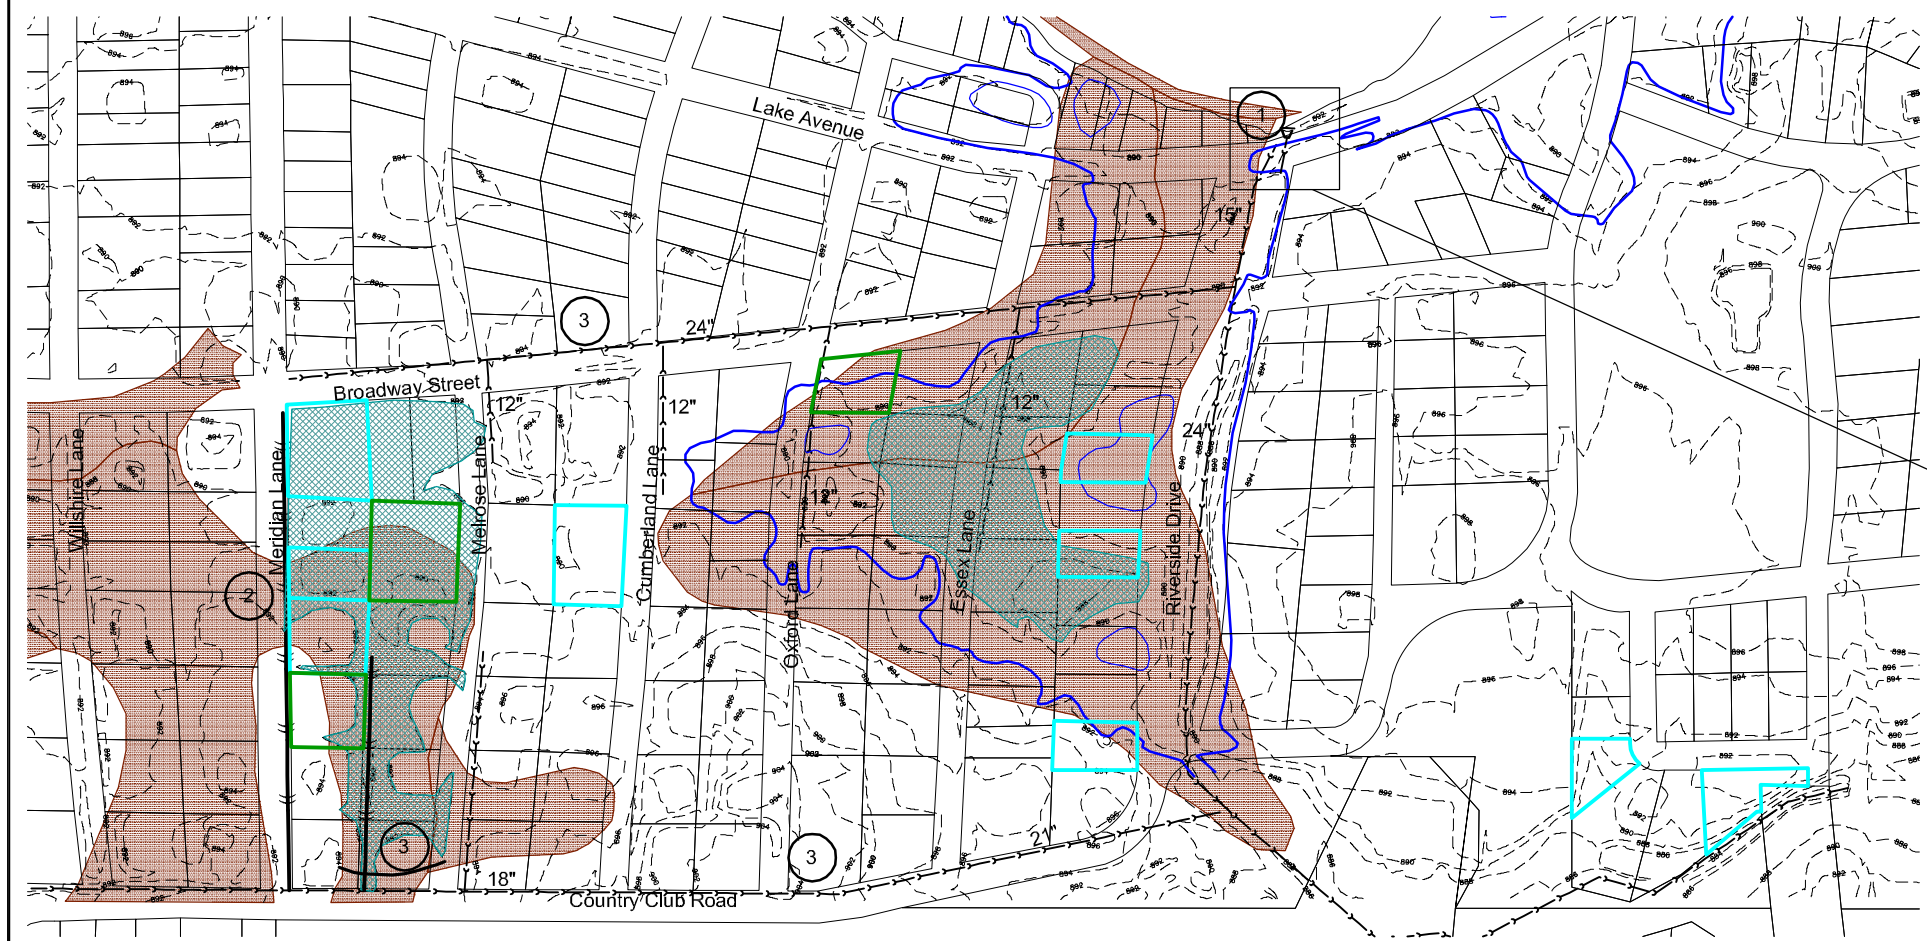
- Potential Alternative - Area 4**
1. Prevent lake water from entering the existing 24" tile sewer.
 2. Add lateral storm sewer to the Country Club Road storm sewer at Meridian and Melrose to better drain Area 4.
 3. Repair, replace, expand the existing storm sewer system with in Area 4.
